FACILITY COMPLIANCE INSPECTION REPORT

Division of Waste Management Solid Waste Section

Date of Site Inspection: July 1, 2013 **Date of Last Inspection:** June 13, 2013

Columbus County LCIDLF
Landfill Road
Whiteville, North Carolina 28472

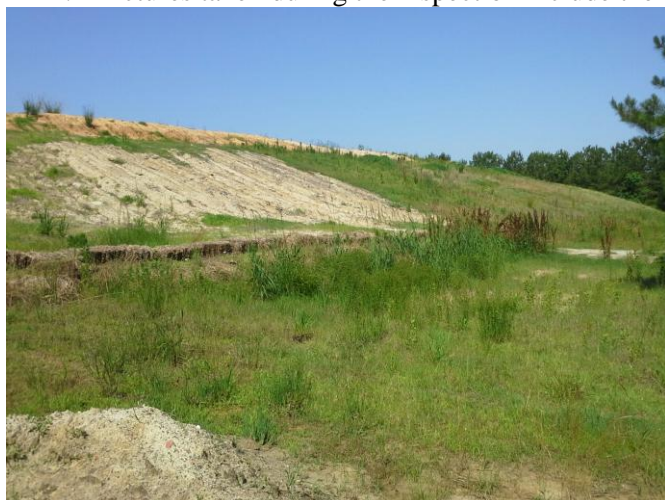
Northern slope, 6/13/13

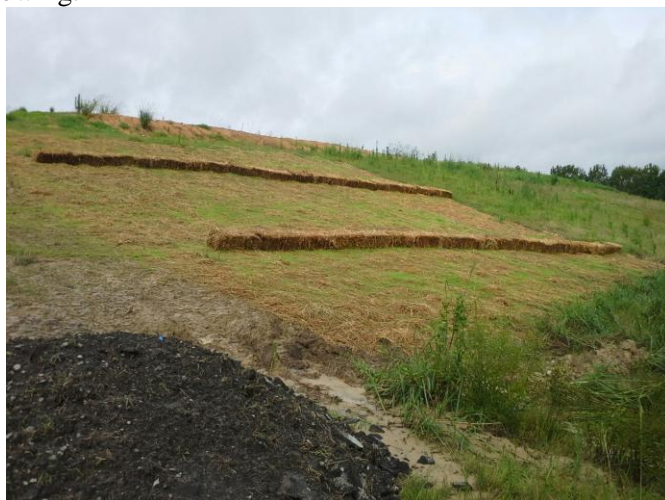
1. This inspection was performed at the request of the county, so as to provide input on actions taken to correct issues noted in the Inspection Report for June 13, 2013. Much progress has been made, despite additional rain events, with efforts continuing.
2. Soil placement, grading, and seeding have occurred on the northeast slope of the landfill. Erosion control measures have also been placed on the slope.
3. Work on the low area across from the working face is continuing. Grading, etc., will need to be completed by July 20, 2013 (thirty days from the original notation).
4. Pictures taken during the inspection include the following:

Northern slope, 7/1/13
